**DEPARTMENT OF TRANSPORTATION**

Contract #: 04-0120F4Cty: SF/ALA Rte: 80 PM: 13.2/13.9File #: 69.28**WELDING INSPECTION REPORT****Resident Engineer:** Pursell, Gary**Address:** 333 Burma Road**City:** Oakland, CA 94607**Report No:** WIR-016389**Date Inspected:** 20-Aug-2010**Project Name:** SAS Superstructure**OSM Arrival Time:** 1900**Prime Contractor:** American Bridge/Fluor Enterprises, a JV**OSM Departure Time:** 700**Contractor:** Zhenhua Port Machinery Company, Ltd (ZPMC), Changxing Island **Location:** Shanghai, China**CWI Name:** See Below**CWI Present:** Yes No**Inspected CWI report:** Yes No N/A**Rod Oven in Use:** Yes No N/A**Electrode to specification:** Yes No N/A**Weld Procedures Followed:** Yes No N/A**Qualified Welders:** Yes No N/A**Verified Joint Fit-up:** Yes No N/A**Approved Drawings:** Yes No N/A**Approved WPS:** Yes No N/A**Delayed / Cancelled:** Yes No N/A**Bridge No:** 34-0006**Component:** OBG**Summary of Items Observed:**

**OBG Segment Trial Assembly**

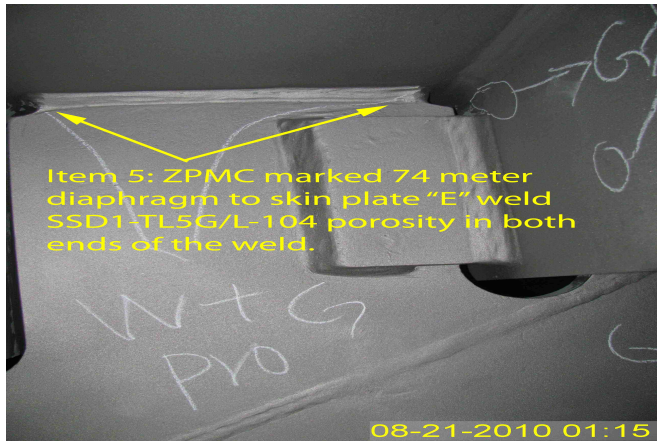
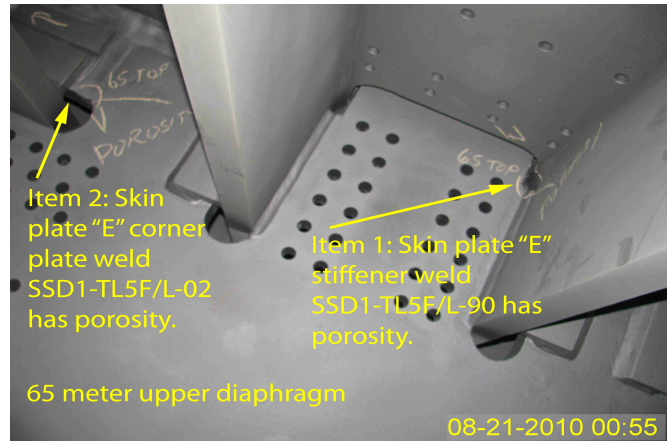
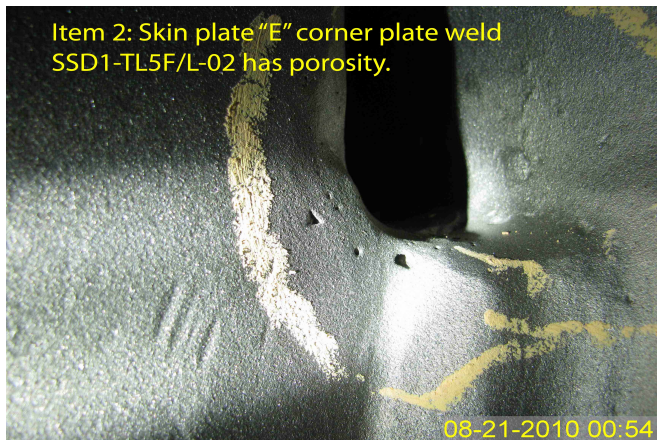
ZPMC requested Caltrans personnel to perform visual inspections of South Tower Lift 2 between the 65M upper double diaphragm to 83 meter elevation on August 21, 2010 at around 00:30 hours following the initial pre-blast cleaning of the steel surfaces. Caltrans QA Inspectors Ken Riley, Mike Hasler and this QA Inspector performed random visual inspections of these areas. This QA Inspector visually observed approximately 40 locations that required grinding to resolve visual weld spatter, arc strikes, shallow nicks, scrapes, and other minor surface rejections and three locations which require weld repairs. ABF and ZPMC Inspectors also performed visual inspections of the areas indicated above and a total of seven areas were identified as needing weld repairs. A "Blast Inspection" incident report has been issued to document these repairs and below is a total list of the weld repairs that were observed by all Inspectors.

1- 65 meter diaphragm to skin plate "E" stiffener weld SSD1-TL5F/L-90 has porosity.

- 2- 65 meter diaphragm to skin plate "E" corner plate weld SSD1-TL5F/L-02 has porosity.
  - 3- 65 meter diaphragm to skin plate "A" weld SSD1-TL5F/L-10 has a gouge in the weld.
  - 4- Skin plate "D" stiffener #1 has a gouge located 300 mm below the 71 meter diaphragm.
  - 5- 74 meter diaphragm to skin plate "E" weld SSD1-TL5G/L-104 has porosity in both ends of the weld.
  - 6- Corner plate to skin plate "C" weld has porosity 50 mm below the 74 meter diaphragm.
  - 7- 74 meter diagonal brace to skin plate "B" weld has undercut 30 mm above the 74 meter diaphragm.
- See the photographs below for additional information.
